CONNECTICUT RIVER BASIN  
HANOVER, NEW HAMPSHIRE

HANOVER CENTER RESERVOIR DAM  
NH 00051

PHASE I INSPECTION REPORT  
NATIONAL DAM INSPECTION PROGRAM

APRIL 1979

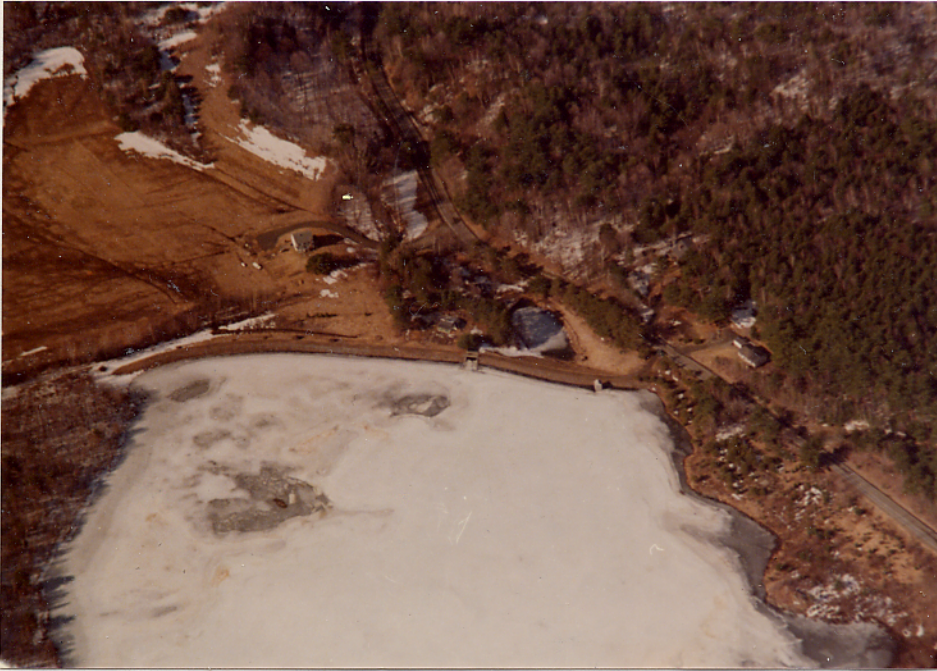
Figure 1 - Overview of Hanover Center Dam.

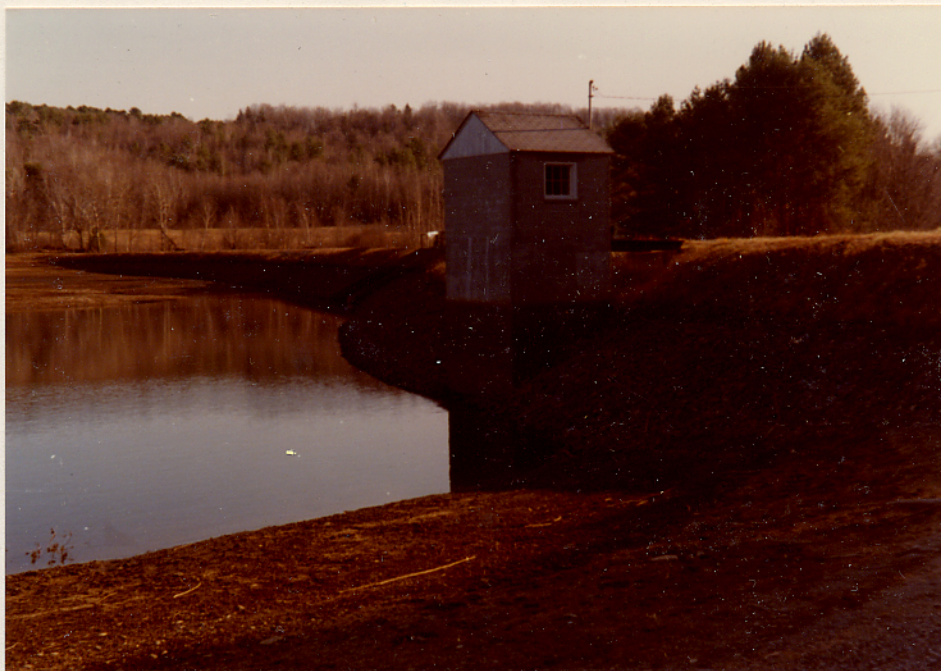
The upstream face of the dam (See Appendix C - Figure 2) has a slope of 2H:1V. At the time of the inspection, the water level in the reservoir was 12.3 feet below the crest of the dam. The portion of the upstream face that was visible above the water is covered with riprap that is in good condition. Some grass is growing up through the riprap between the normal pool elevation and the crest.

Figure 2 - Looking south at upstream face of dam.

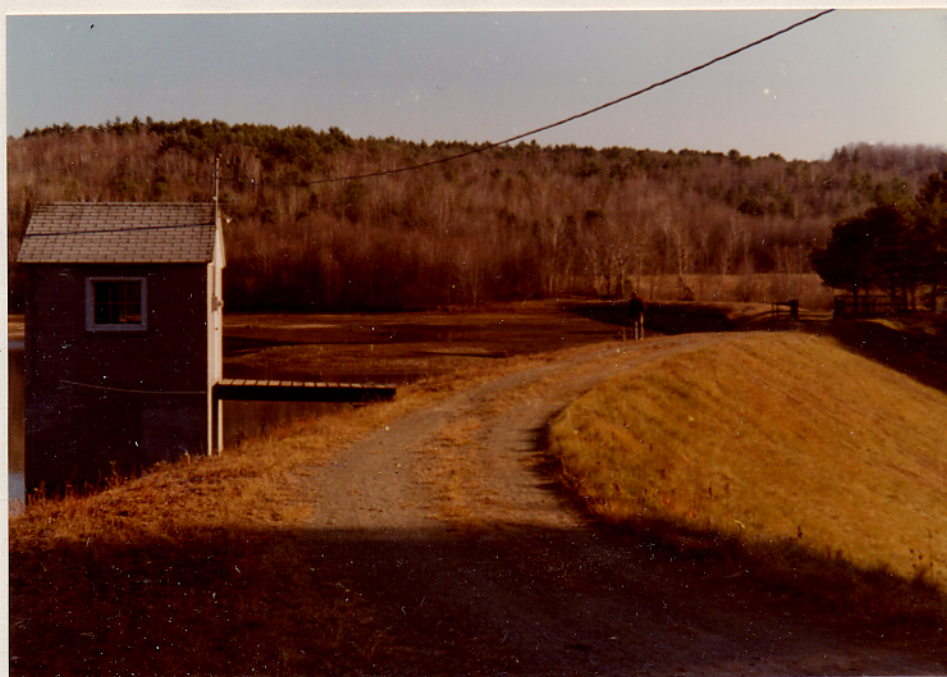
Figure 3 - Looking south along crest of dam.

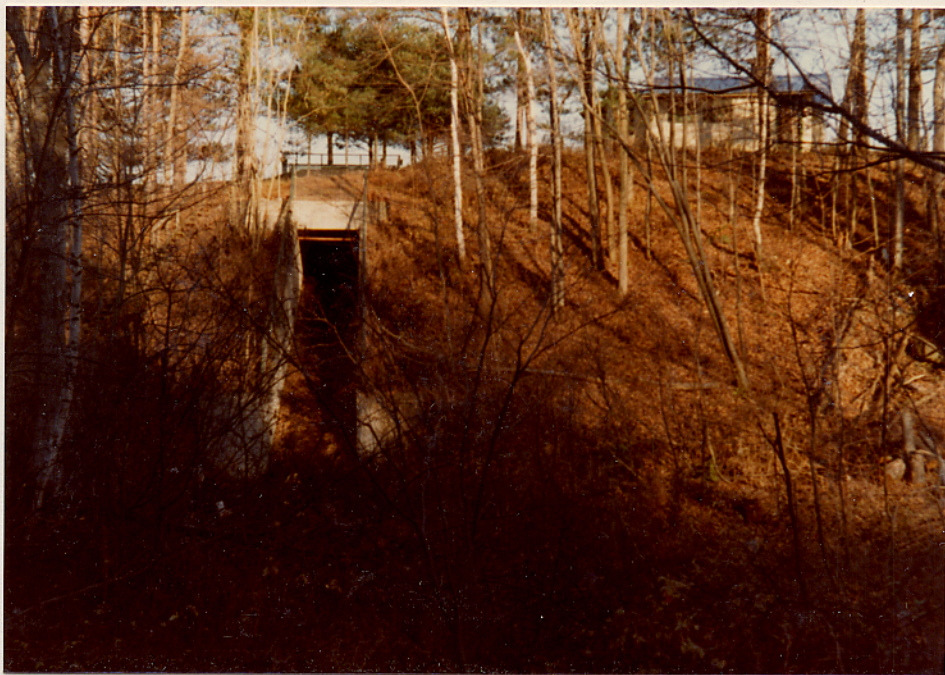
A slight unevenness of the downstream slope of the dam between the south abutment and the center knoll was noted. It does not appear that this unevenness is the result of any seepage or stability problem.

Figure 4 - View of downstream face of dam and chute spillway.

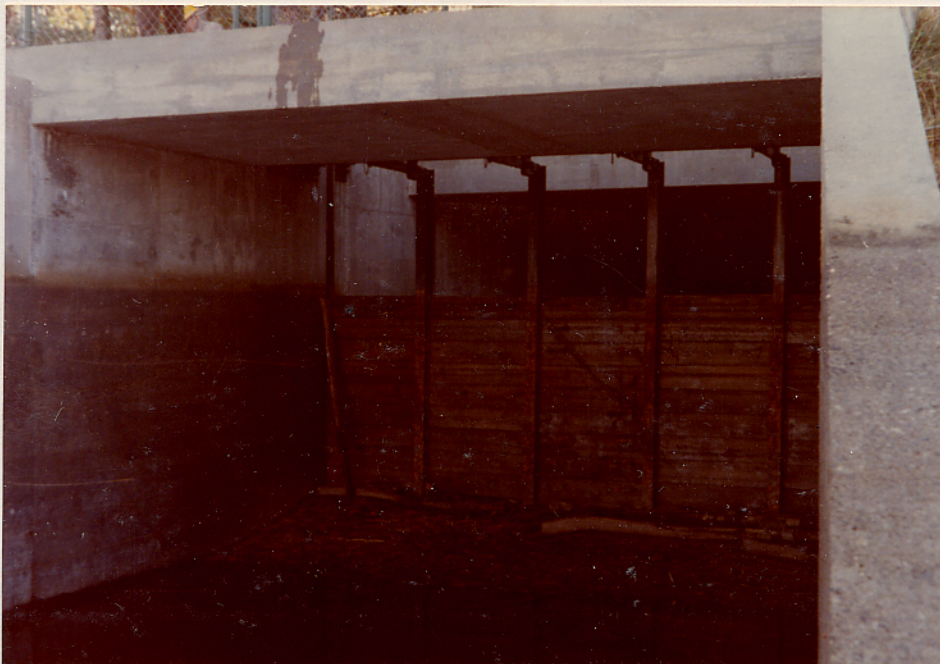
Figure 5 - Looking downstream at stoplogs in chute spillway.

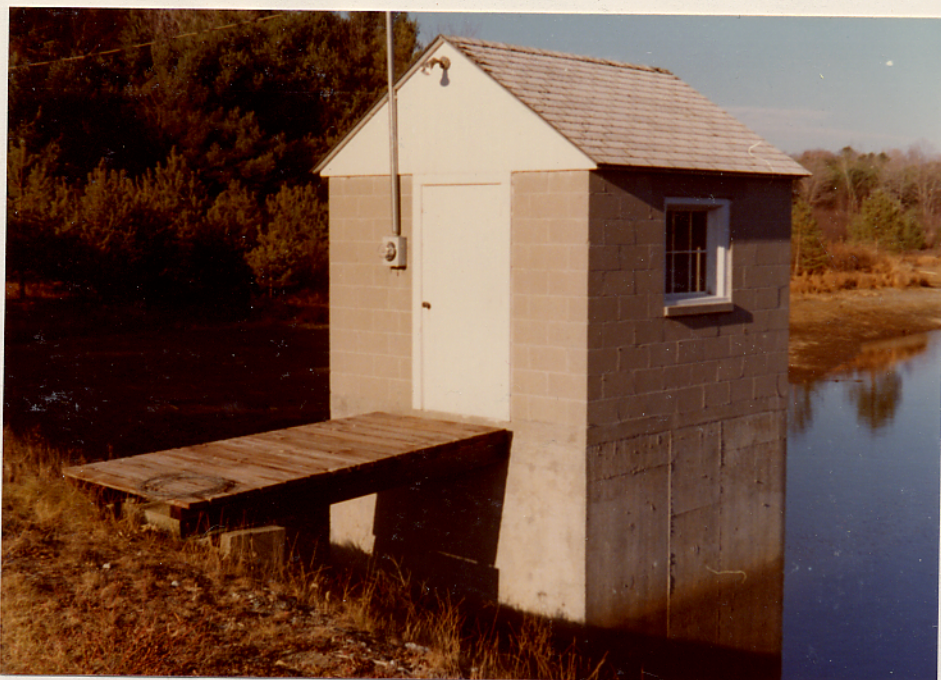
(2) Water Supply Valve Structure. A 10-foot square concrete structure that supports the valvehouse (See Appendix C - Figure 6) is located approximately 80 feet from the north end of the dam on the upstream face. The valves control flow into the Town of Hanover water supply system. The concrete structure was observed to be in good condition.

Figure 6 - Looking at gatehouse which contains valve for controlling discharge into water supply line and fish pond.

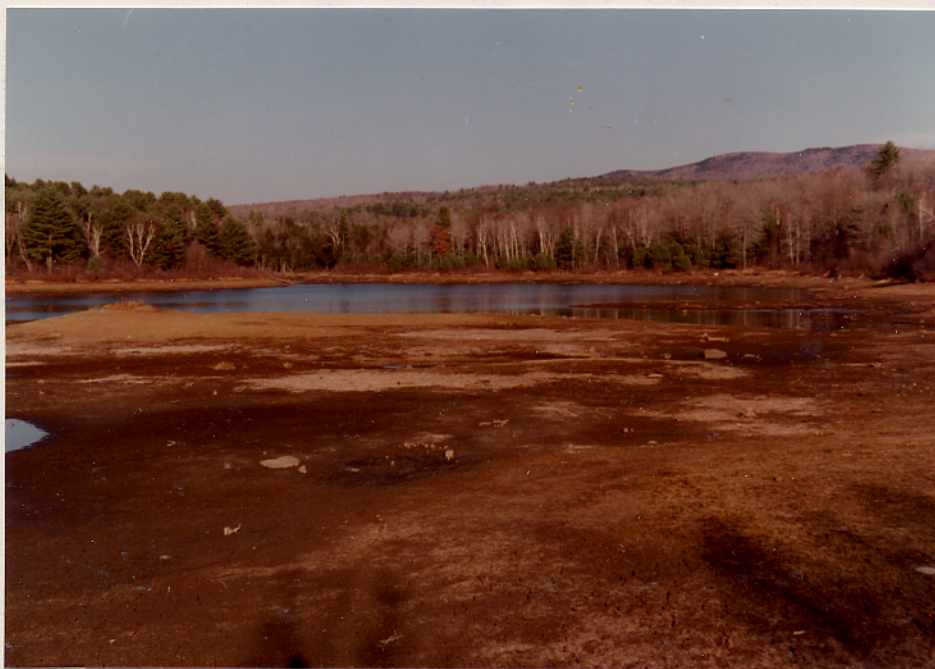
Figure 7 - Looking east at upstream reservoir.

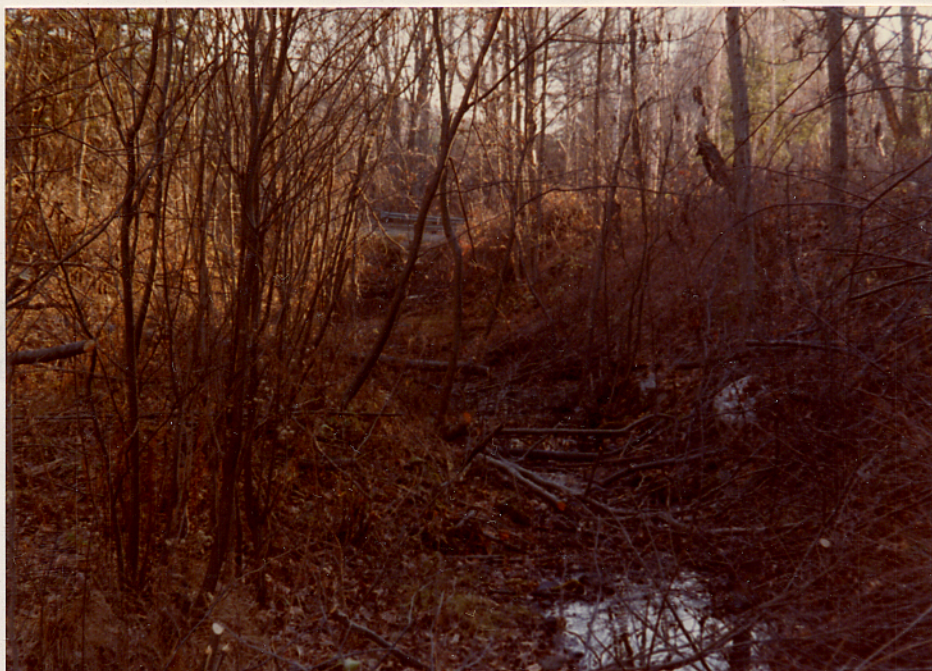
A minor unevenness of the downstream slope and a shallow, small depression with standing water near the downstream toe were observed, but neither condition appears to be related to either a seepage or stability problem. Brush is overhanging the discharge channel and some cut brush and felled trees were noted in the discharge channel.

Figure 8 - View of discharge channel below chute spillway outlet.
